Aquatic Habitat Enhancement and Ecological Improvement of Lakeshore Village

*Final Report of the Lakeshore Village Condominium Association (LSVCA)
in Fulfillment of the Requirements of the Comprehensive Conservation and Management Plan
of the Sarasota Bay Estuary Program*

May 14, 2019

Prepared by
Michael T Barbour, PhD
Past President of LSVCA and Aquatic Ecologist

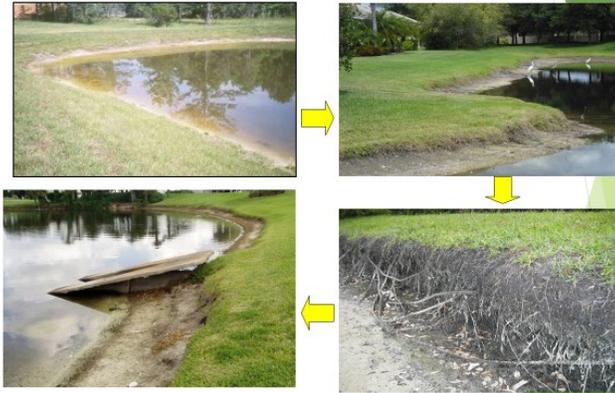
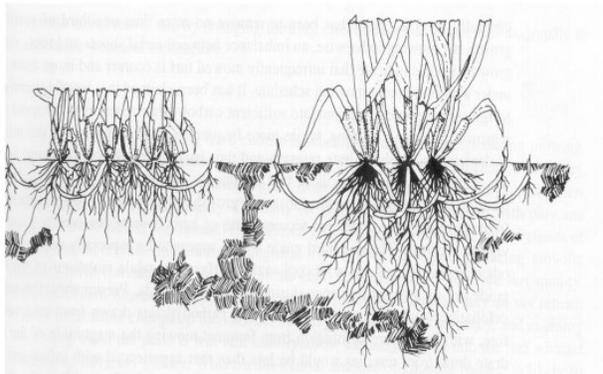
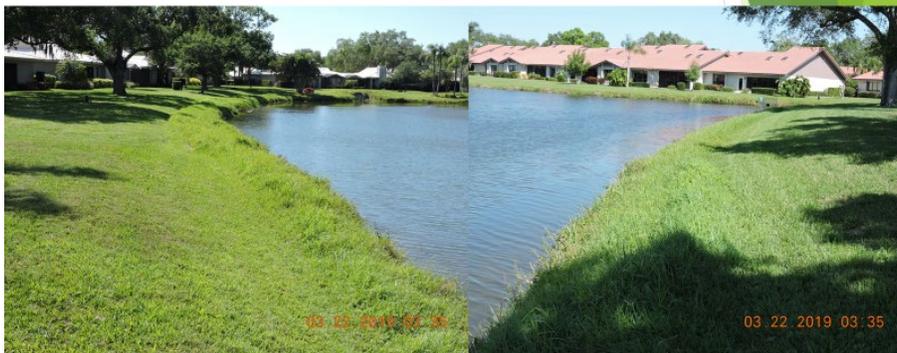
Attachment 1:
Progression of bank stabilization issues and correction through buffer zones. Slides taken from workshop presentation to residents of Lakeshore Village.

Shoreline Erosion Progression

Influence of Plant Height on Plant Health

Example of our Buffer Zone here at LSV

Our lakes are 30 years old and very mature. Over the years we have lost bank structure through a management system that encouraged mowing down to the lake margin. Effects were realized by both physical degradation from mechanical equipment and chemical runoff from managed lawns. As part of this project, a buffer zone was established around each of LSV's four lakes. This buffer zone consists of no mowing within a 4 ft-wide perimeter of each lake and allowing the grasses to grow to a height of 14-16 inches. This in turn has allowed the root systems to grow deeper in the soil and has greatly stabilized our banks, thus reducing further soil loss. See **Attachment 1**, which is a collection of three slides taken from a presentation made to the residents of Lakeshore Village.

The benefit of establishing buffer zones along the perimeter of each lake which are low or no maintenance has been realized in stabilizing our bank structure and hardening the soil beneath to prevent soil loss. We have experimented with wildflower plantings in the buffer zone and are discussing ground cover alternates to the grass buffer zone. However, the acceptance by the community for these grassy and sometimes weedy zones has been admirable.

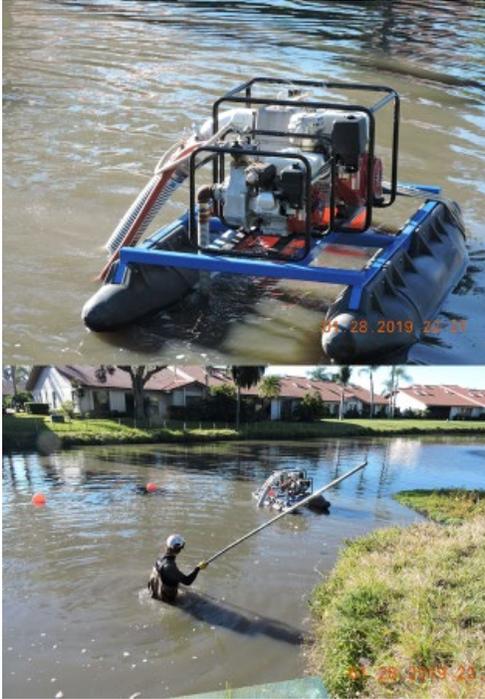
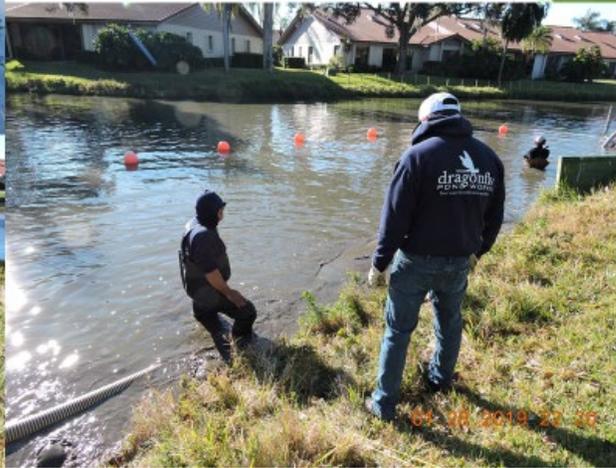
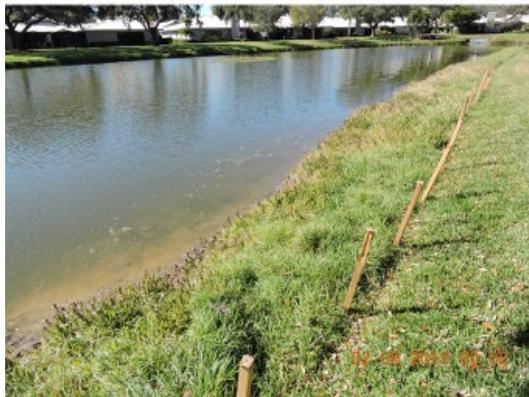
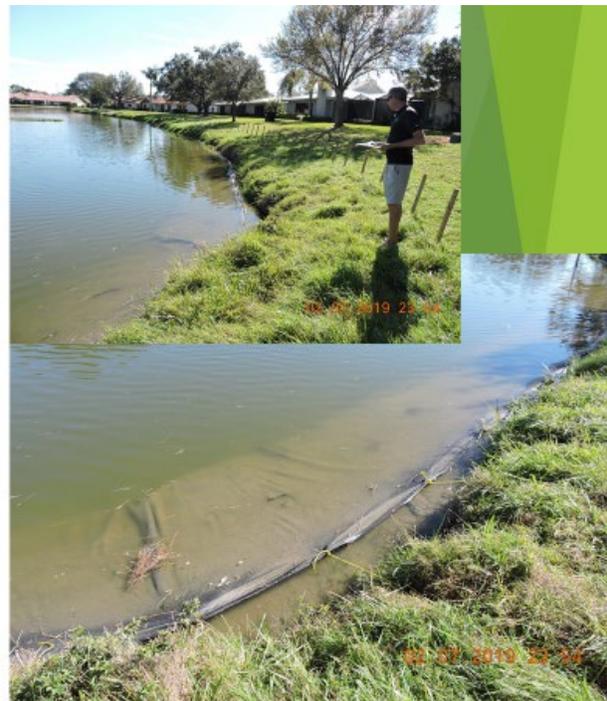
Attachment 3: Illustration of using Geotextile Tubing to sequester sediment from the lake and to form littoral shelves in lakes that had severe loss of the littoral zone.

Filling the Geotextile Bags

Placing the Bags in the Water

The loss of any semblance of littoral zones in our lakes is substantial over our last 30-year period due to a management procedure that essentially was to remove any aquatic plants from our lakes. The re-establishment of these important zones required some innovative methods in this project. We elected to use geotextile tubing that were 5 feet wide and extended the length of the sections to be repaired. Bottom sediment from within the lake was pumped into the tubes which were anchored to the shore edge. Once completed, the filled bags were left to settle in until aquatic planting (Component 3) was accomplished. At this time, the geotextile tubes were maneuvered to provide a gentle slope of shallow water to form our new littoral shelves. **Attachment 2** provides an overview depth contour of the lakes and the identified sections of the littoral zones. **Attachment 3** is a collection of pictures showing the geotextile work. This phase of the project has been observed closely by Sarasota County because the technique may serve as a model for other associations with some age on them and which are facing the same issue of loss of littoral shelves. The existence of healthy littoral zones is critical to establishing ecological stability.

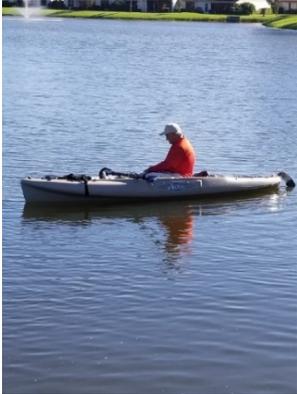
(Attachment 6) LAKESHORE VILLAGE
Water Quality Results for Egret Lake and Cormorant Lake
Multiple Samples taken: December 11, 2017 – December 5, 2018

As we strive to improve the water quality of our lakes at Lakeshore Village, we are taking monthly water samples in two of our lakes for Florida LAKEWATCH. Presented here are our water quality data, which emphasize results for phosphorus, nitrogen, chlorophyll, and water clarity. These four parameters are regarded as the best suite of indicators of overall water quality.

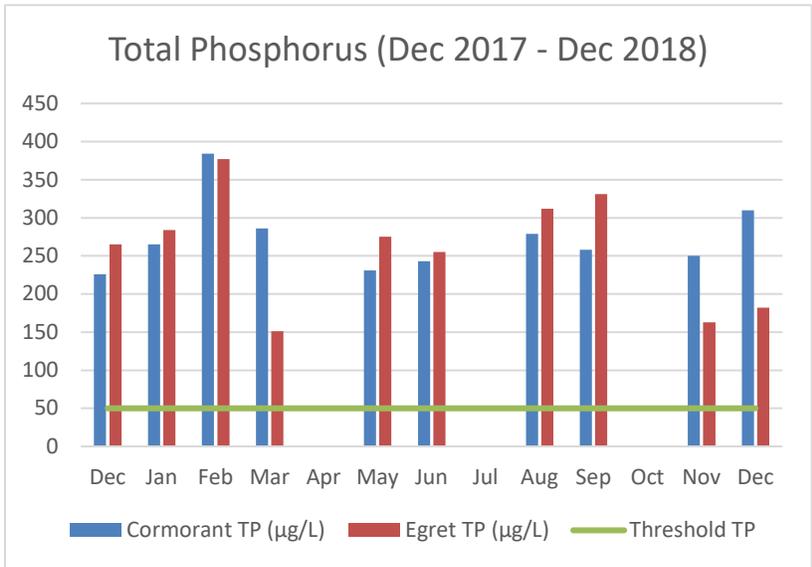
Elevated levels of **phosphorus** can cause shifts in water quality balance and is the most common cause of undesirable growth of aquatic weeds and algae. Lawn and landscape fertilizer runoff are another major source of phosphorus in lakes. Both Cormorant and Egret Lakes exceed the nutrient criteria.

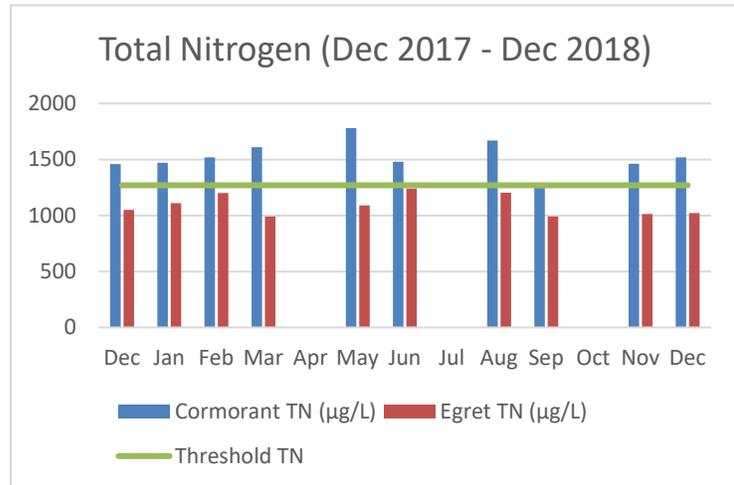
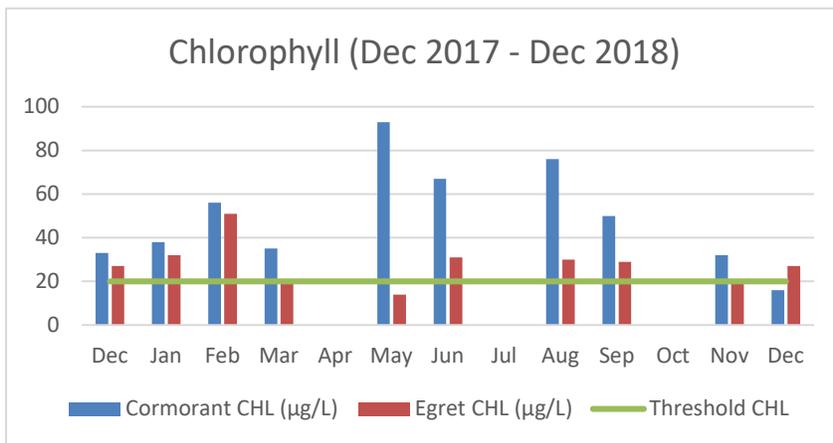
Nitrogen can promote plant and algae growth when combined with phosphorus. Nitrogen levels should remain in the low range to maintain a healthy lake system. While Cormorant exceeds the criteria, Egret is below but approaches the threshold.

Chlorophyll a is measured to estimate the level of eutrophication in lakes, evident by the amount of phytoplankton present. Chlorophyll a, one of the green pigments involved in photosynthesis, is indicative of algal concentrations and of nutrient enrichment. Excessive phytoplankton concentrations, as indicated by high levels of Chlorophyll

a, cause adverse impacts on dissolved oxygen levels due to biological oxygen demand as plant life decays. Both lakes have high levels of Chlorophyll, but more so in Cormorant Lake.

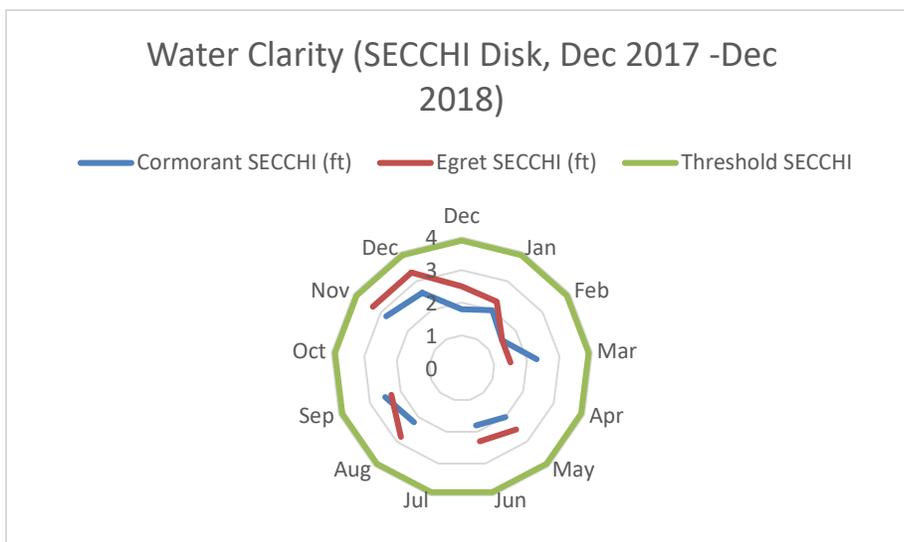
Secchi depth is a mechanical test to judge the **depth of clarity** of a body of water. Generally, nutrient rich lakes tend to have Secchi depths less than 8 feet and highly enriched sites less than 3 feet. However, many lakes are exceptions to this rule based on other parameters, and Secchi in isolation cannot

always diagnose a lake's overall health. Cormorant and Egret Lakes have water clarity less than desired.
